Fracture toughness testing of the GEN40 aluminum single-axis knee joint

The date of the experiment: August 16, 2011

In this paper we discuss the fracture toughness test results for our newly developed single-axis knee joint.

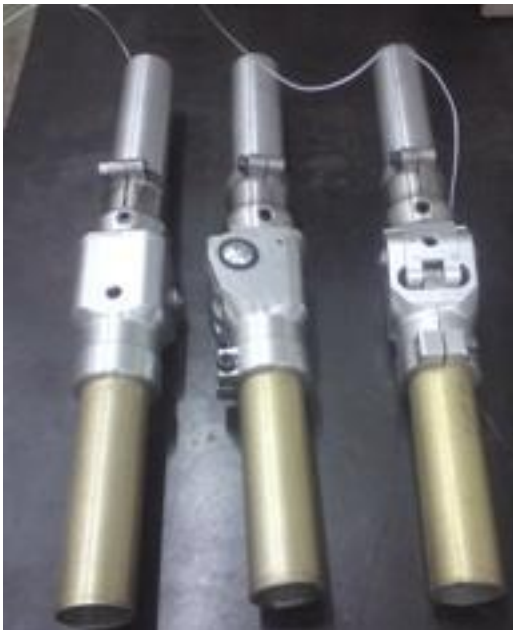
In the joint currently in use the axle is attached to the body (bottom part), and the relative movement is achieved with a bronze insert in the top part. In contrast, the new joint contains bearings in the bottom part, which creates a more advantageous load configuration. The assembled joints can be seen in Figure 1.

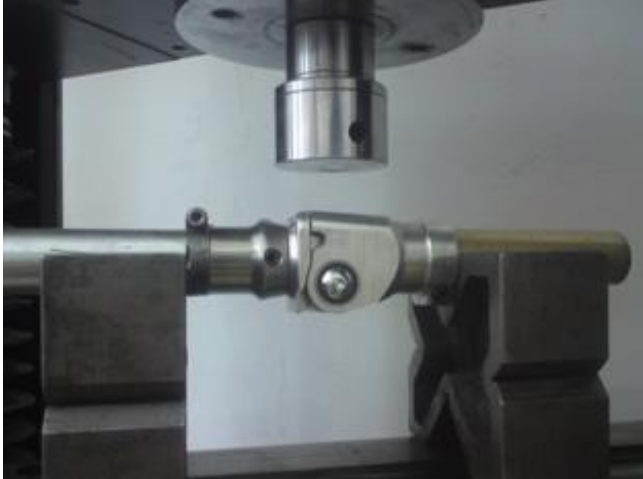
In the first run the front of the front of the knee joint was facing upwards, as seen in Figure 2.

Figure 2. The first configuration.

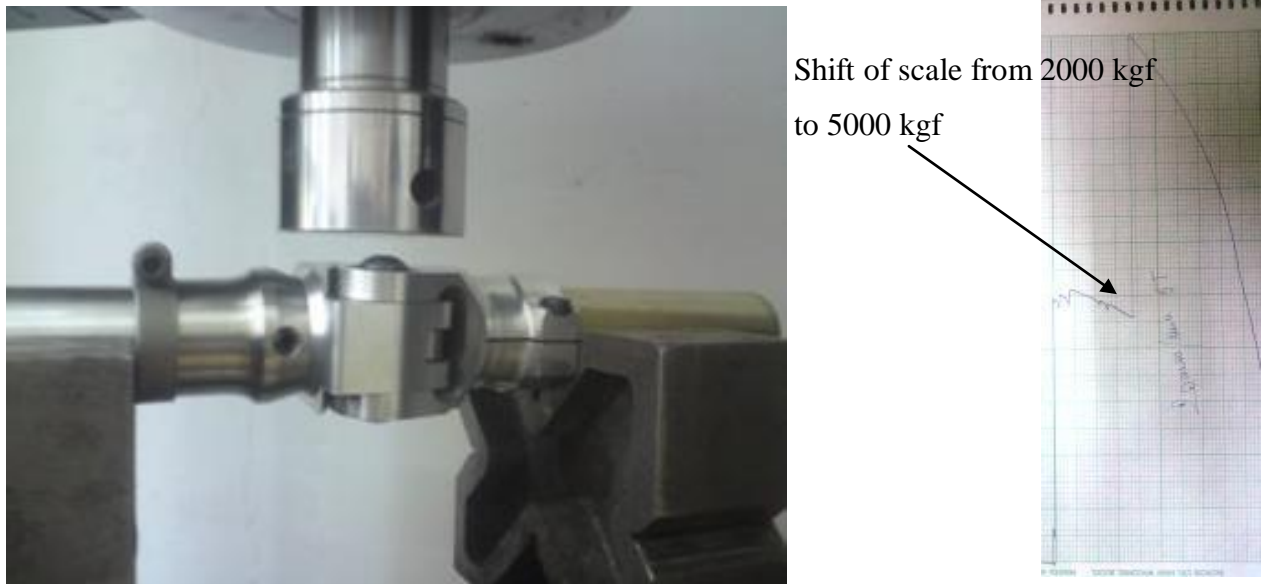
In the second run the side of the joint was facing the load cell (Figure 4a), providing lateral load. The graph is shown in Figure 4b.

Figure 4. a. The second setup, b. Force-strain plot of the second configuration.

At first the 2000 kgf vertical scale was used, but the upper limit was reached so a switch was made to 5000 kgf. This shift is represented by the large step in the graph. The first deformation was observed at 2420 kgf at the adjustment core. At 2560 kfg both the bearing housing (the “ears” of the joint) and the bearing itself broke.

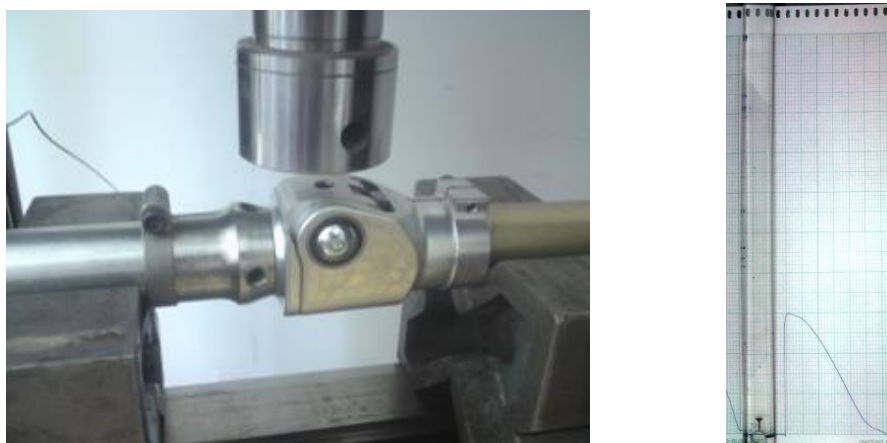
In the third configuration the back of the joint was facing the load cell (Figure 5a). With this setup the lock mechanism was targeted.

Figure 5. a. The third configuration, b. Force-strain plot of the third configuration. The vertical scale represents 2000 kgf.

At 600 kgf the pin in the lock mechanism failed due to the shear stress. It should be noted that the new joint contains a 5 mm diameter pin instead of the 4 mm pin in the old model. This is a 56% increase in cross section area which explains the increased shear strength.
